Diagnosis – Complaint Related Diagnostic Chart – Overall Function

Diagnosis – Complaint Related Diagnostic Chart – ATF Leak Complaints (Overall)

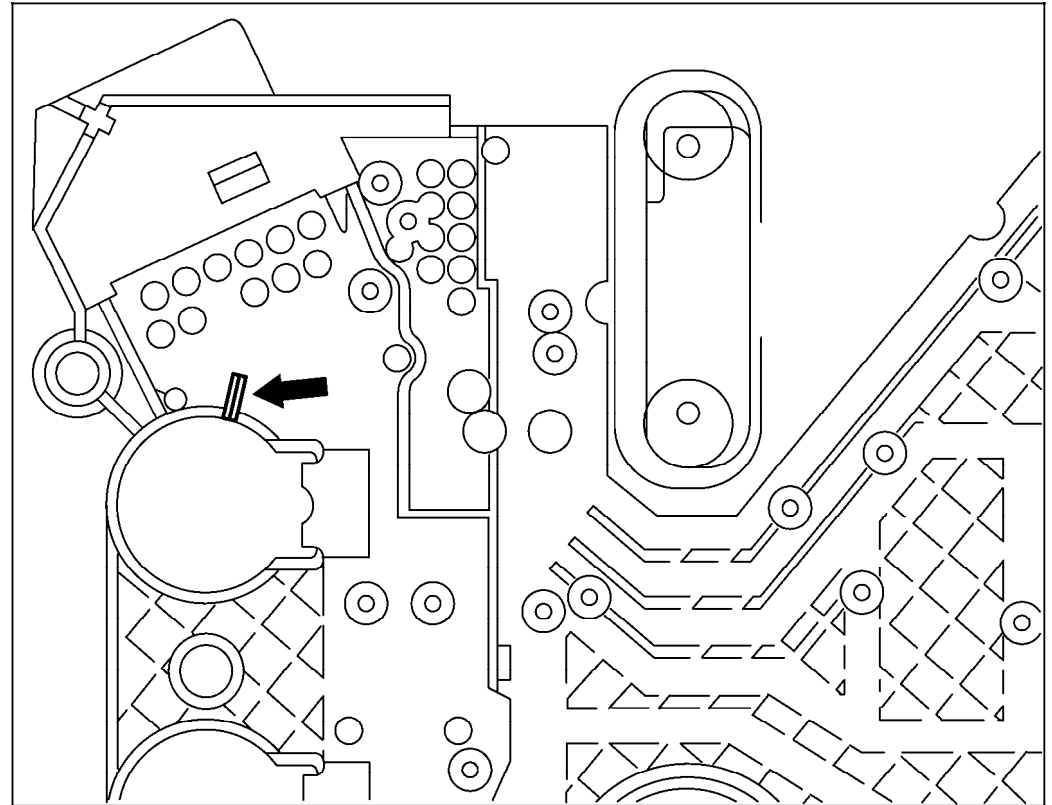
Figure 1

Prior to starting any repairs, check the ATF fluid level.</p>	<p>Distorted O-rings</p> <p>Distorted connector</p> <p>The electrical conductor plate is not resting properly on the valve body housing. Therefore, the connector is not properly centered in the bore of the support plate and does not seal completely around its circumference.</p> <p>Electrical connections at the electrical conductor plate are leaking ATF. Therefore, ATF leaks into in harness, at times to ETC control module (N15/3).</p>	<p>Replace O-rings</p> <p>

(**arrow**, remove boss in electrical conductor plate)

Applies up to transmission number 1309692 only, thereafter modified material used.</p> <p>Carefully remove boss on the electrical conductor plate (Figure 1, next page, arrow), to allow proper seating.</p> <p>
