Electrical Test Program – Component Locations

Loudspeaker Components in Front Passenger Compartment (Sedan)

Loudspeaker Components in Rear Passenger Compartment (Sedan)

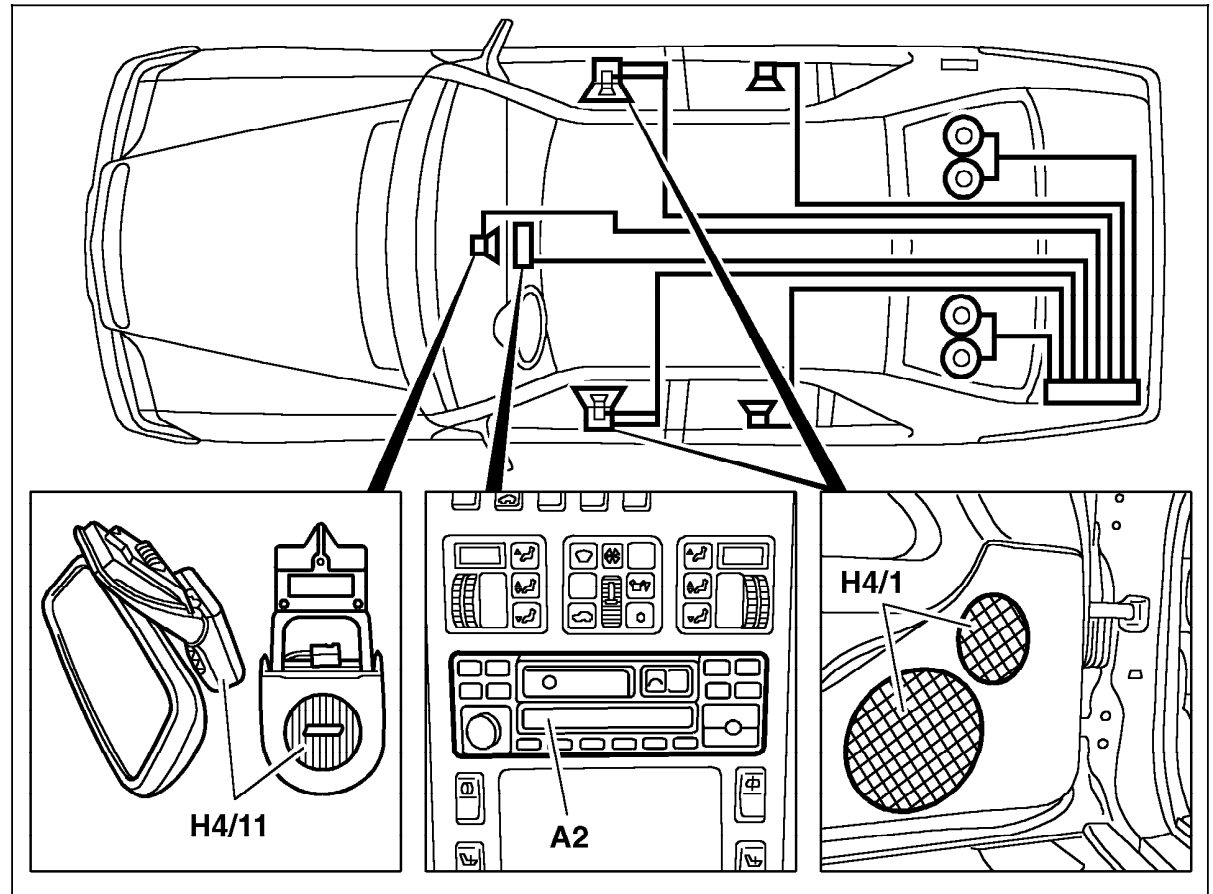
Figure 1

- A2 Radio
- H4/1 Left front door speaker group
- H4/2 Right front door speaker group (not shown)
- H4/11 Center fill tweeter speaker

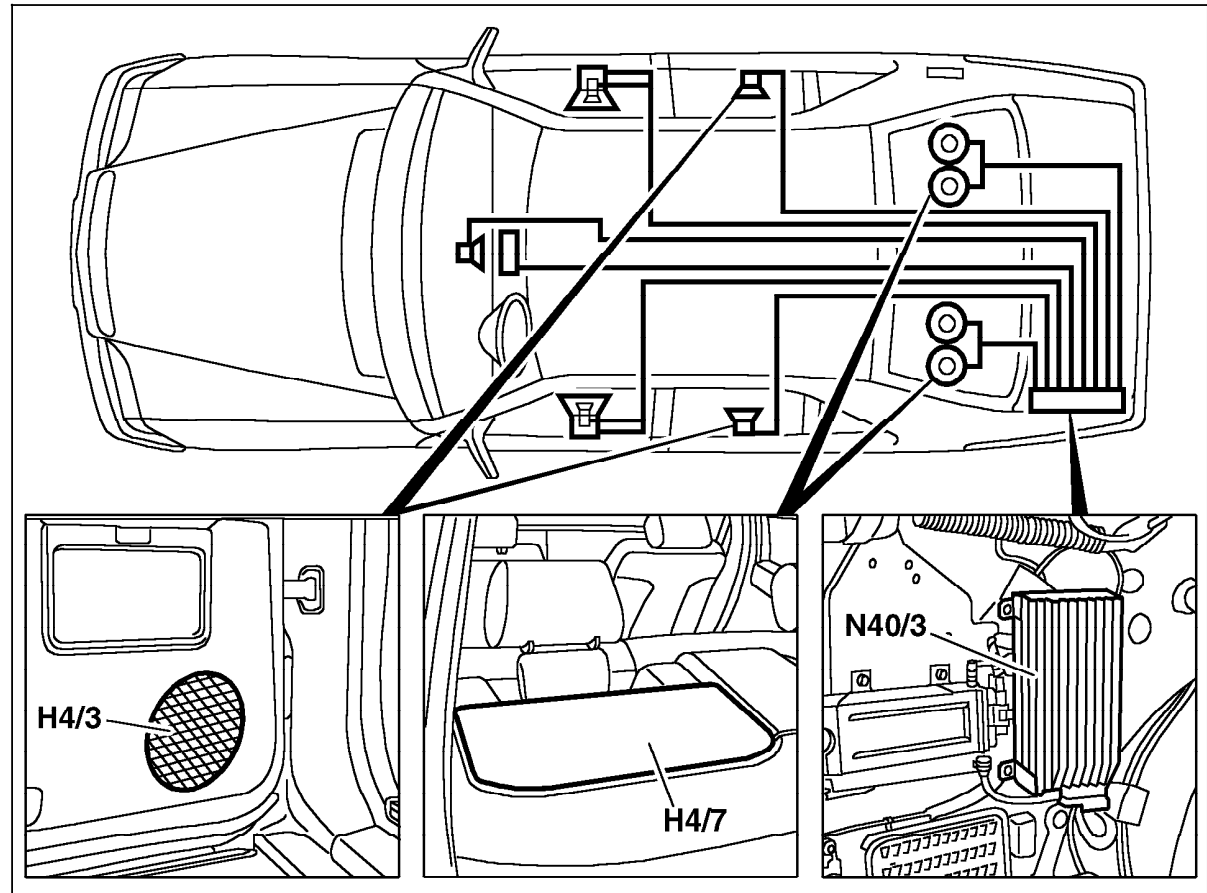
Figure 2

- H4/3 Left rear door speaker
- H4/4 Right rear door speaker (not shown)
- H4/7 Left rear speaker group
- H4/8 Left rear speaker group (not shown)
- N40/3 Left/right audio power amplifier
