### Electrical Test Program – Component Locations

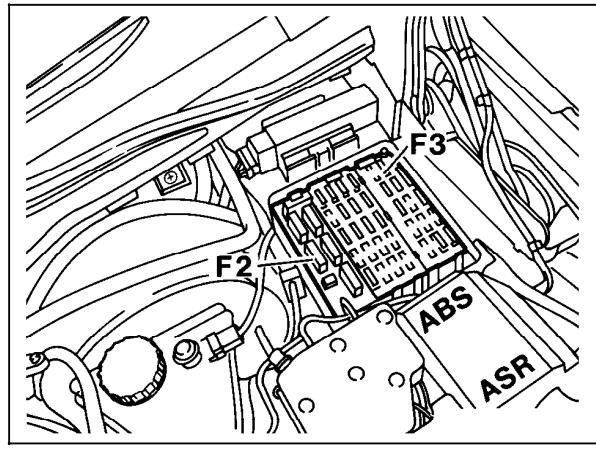
Figure 1

F3      Fuse box

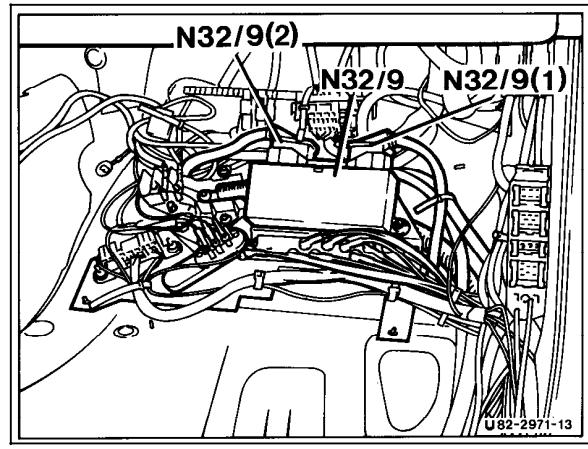
Figure 2

- N32/9    Electrical mirror/steering column adjustment control module  
(1)       Connector 1  
(2)       Connector 2

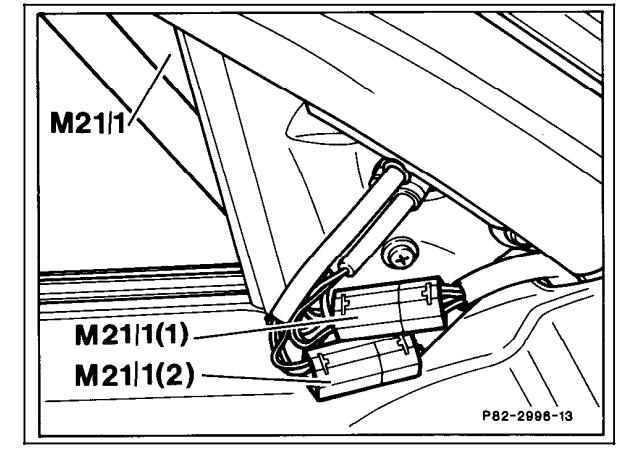
Figure 3

- M21/1    Electrically adjustable and heated driver's side outside rearview mirror  
(1)       Connector 1  
(2)       Connector 2

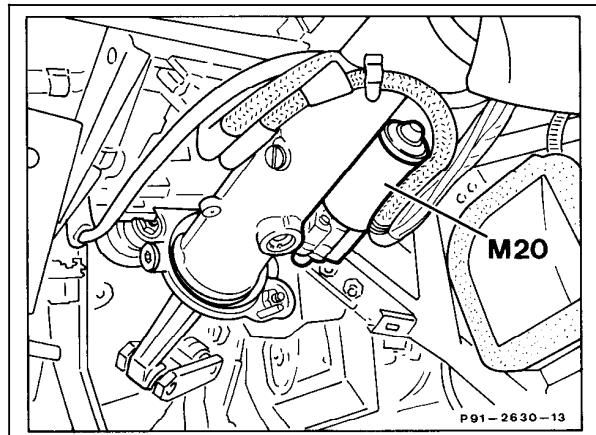
Figure 4

M20      Adjustable steering column motor
