Diagnosis - Function Test (driver/passenger-side airbag)

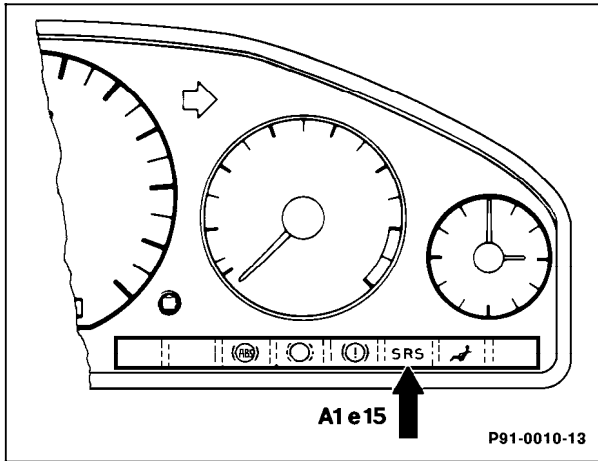
Figure 1
A1e15 SRS malfunction indicator lamp

Test step/Test sequence	Test condition	Nominal value	Possible cause/Remedy ¹⁾
⇒ 1.0 Supplemental Restraint System	Ignition key in position "1".	SRS malfunction indicator lamp (A1e15) comes on for approximately 4 seconds.	DTC Memory 12
