Electrical Test Program - Component Locations

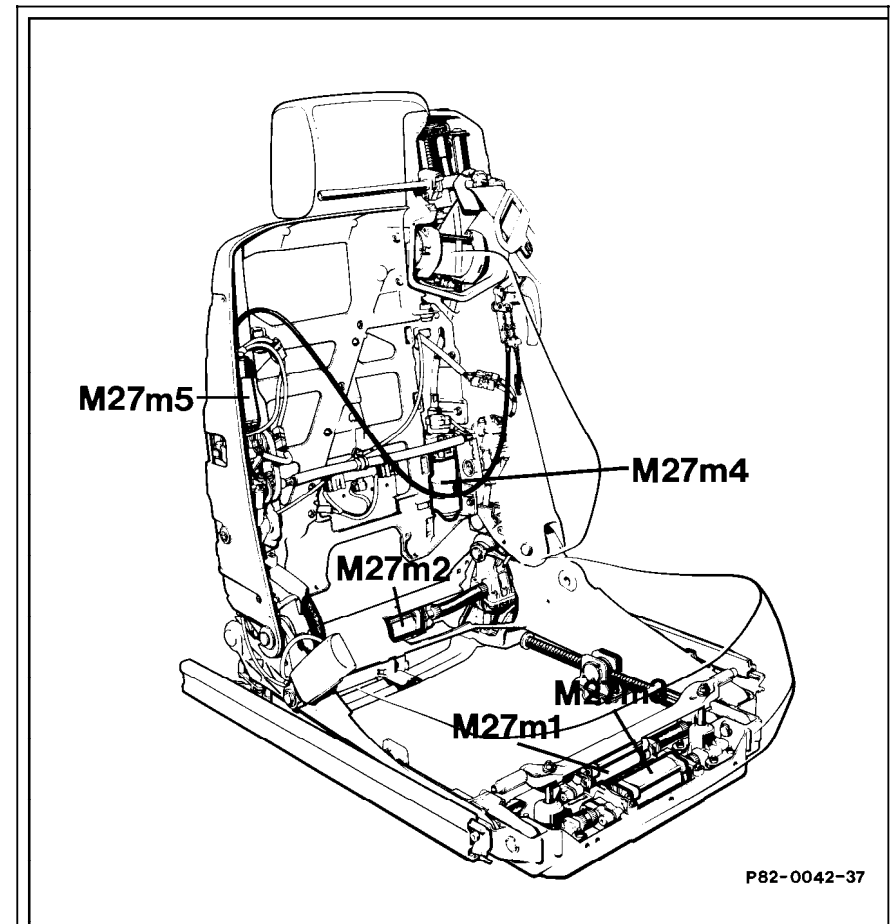
Figure 1

- M27 Left front ESA motor group (with memory)
- M27m1 Fore/aft motor
- M27m2 Rear raise/lower motor
- M27m3 Front raise/lower motor
- M27m4 Head restraint raise/lower motor
- M27m5 Backrest fore/aft motor

Note:

Right power seat layout (not pictured) similar to left

- M28 Right front ESA motor group (with memory)
- M28m1 Fore/aft motor
- M28m2 Rear raise/lower motor
- M28m3 Front raise/lower motor
- M28m4 Head restraint raise/lower motor
- M28m5 Backrest fore/aft motor

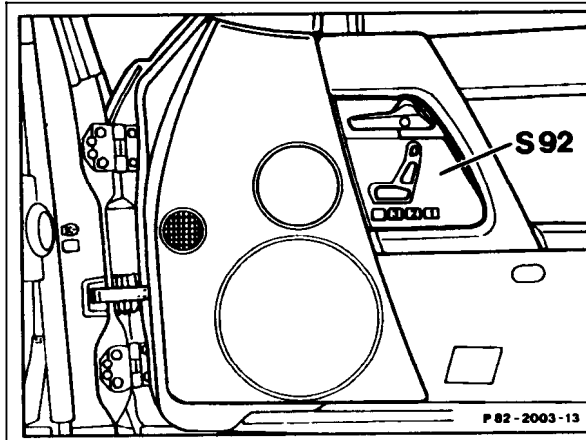
Figure 2

- S92 Right front ESA switch group (with memory)
- S91 Left front ESA switch group (with memory)
(not pictured, layout similar to right)

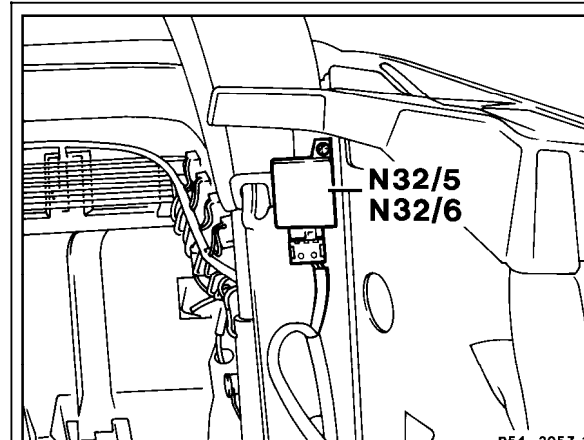
Figure 3

- N32/5 Left seat proximity control module (soft top compartment panel removed)
- N32/6 Right seat proximity control module
(not pictured, layout similar to left)

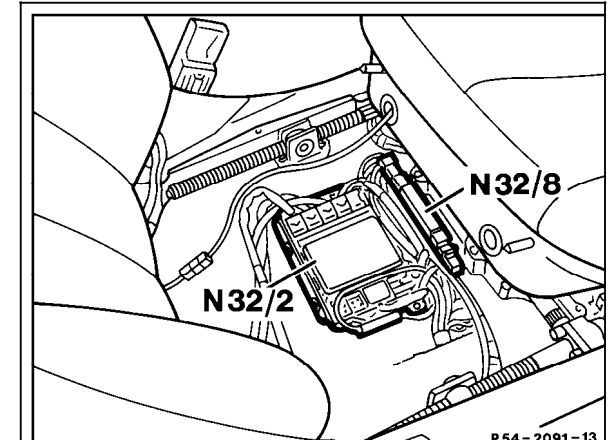
Figure 4

- N32/2 Right front ESA control module (with memory)
- N32/8 Right backrest lock safety package
- N32/7 Left backrest lock safety package
(not pictured, layout similar to right)
- N32/1 Left front ESA control module (with memory)
(not pictured, layout similar to right)

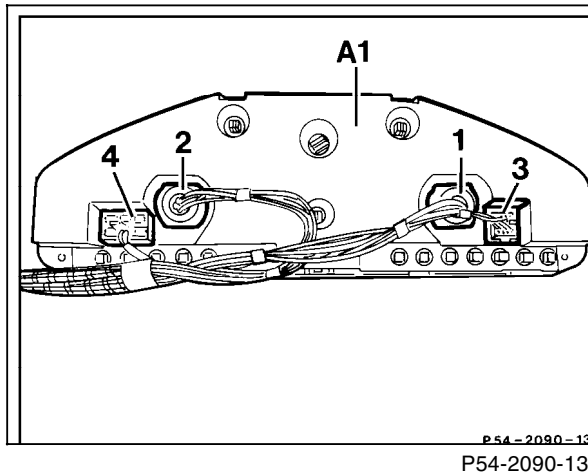
Figure 5

- A1 Instrument cluster, reverse side
- 2 Connector, with terminal no. 7 for backrest lock warning lamp
