Electrical Test Program – Component Locations

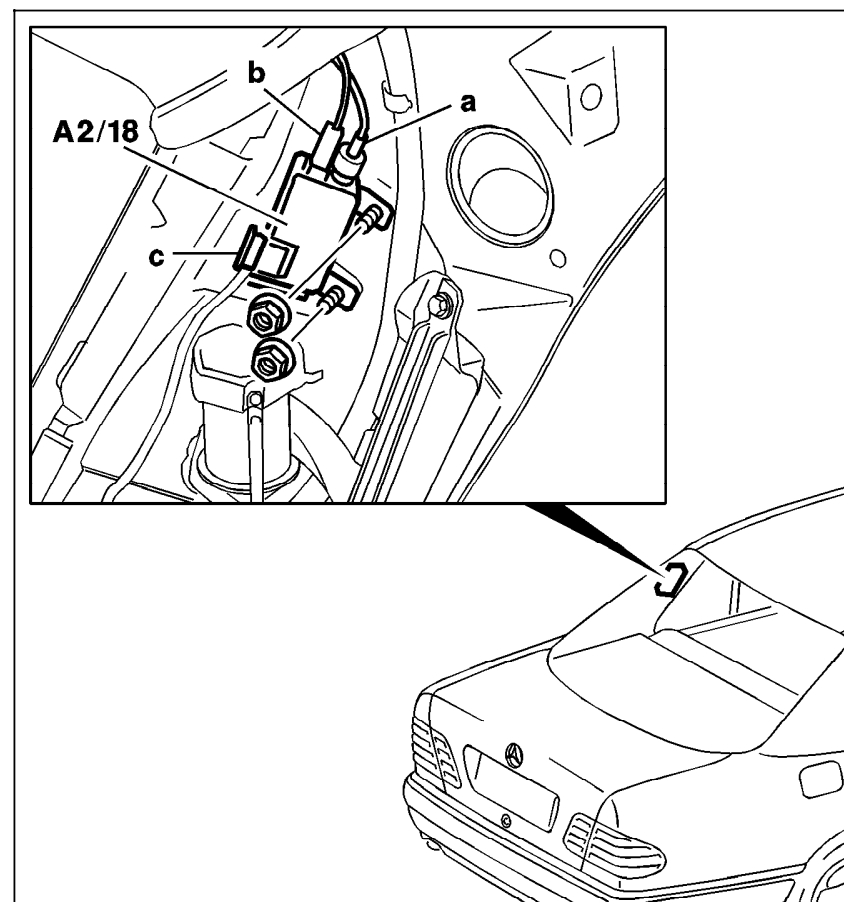
Figure 1

- A2/18 FM/AM rear window antenna amplifier
- a High frequency connection wire to radio
- b Automatic antenna control wire from radio
- c Signal wire from rear window antenna

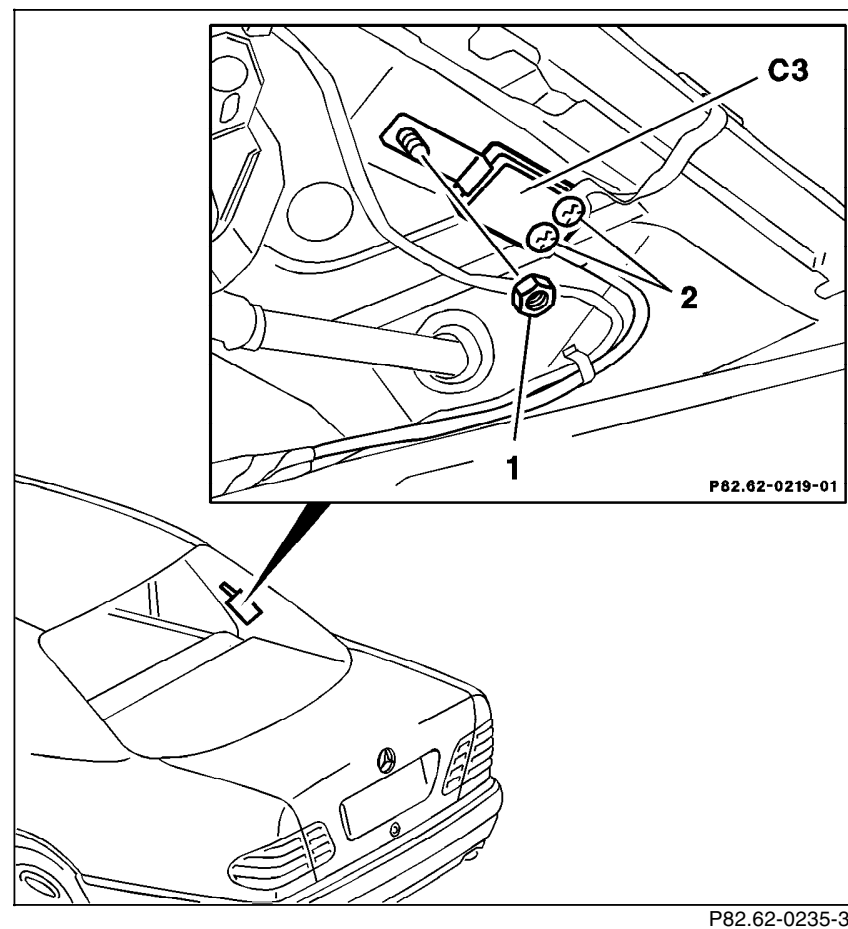
Figure 2

C3 Electrolytic capacitor (rear glass noise suppressor)
(right C-pillar)
